# **SOUTH HAMPTON TOWNSHIP HISTORIC CEMETERIES: DOCUMENTATION, CONDITIONS AND PRELIMINARY PRESERVATION MANAGEMENT PLAN**

## **I. Introduction**

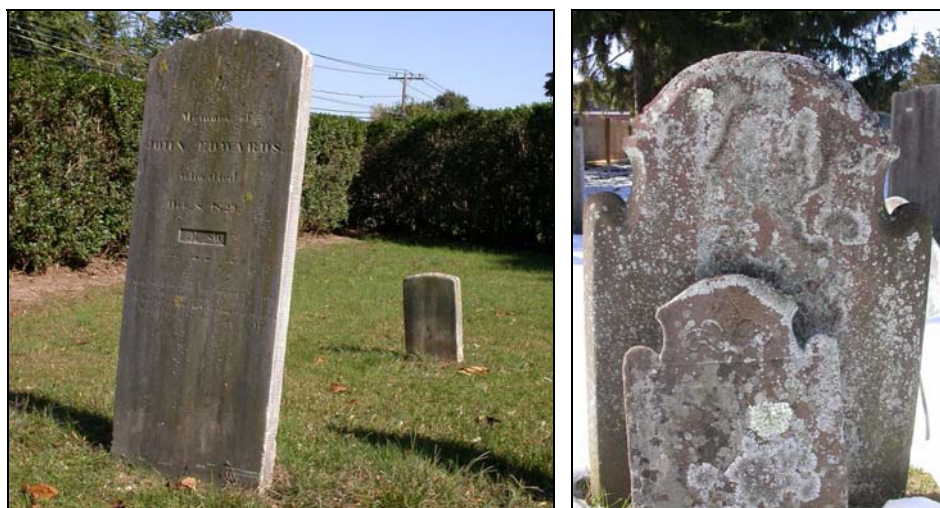
*Headstone with Footstone in original position (left), Footstone relocated (right)*

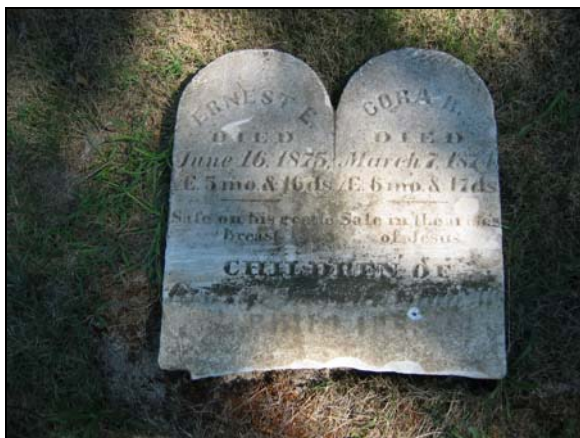
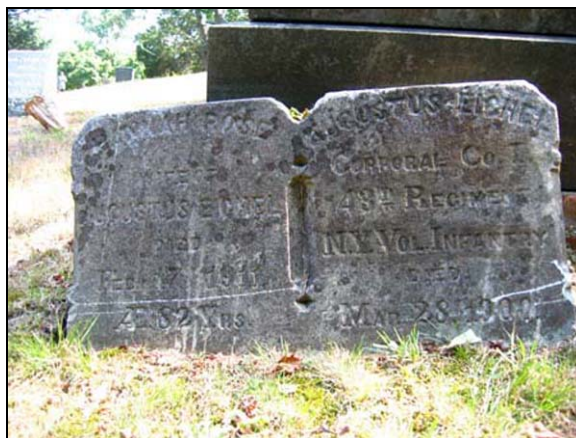
*Double Form Markers: East Quogue #2082, North Sea #3020*

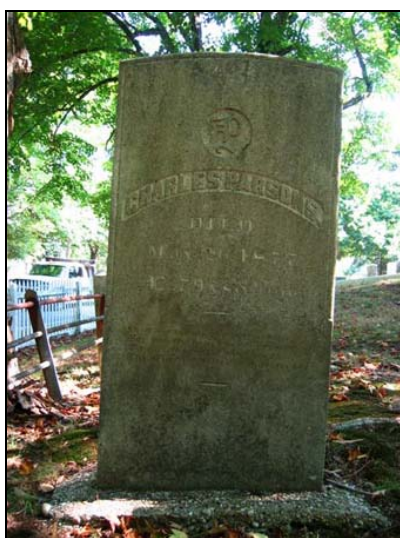
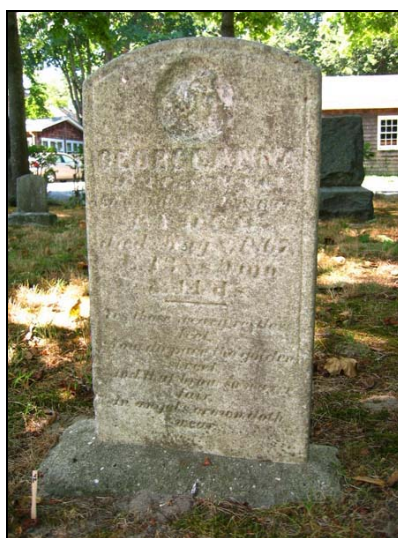
*Later additions: Concrete bases to #3074 in North Sea, #2042 in East Quogue*

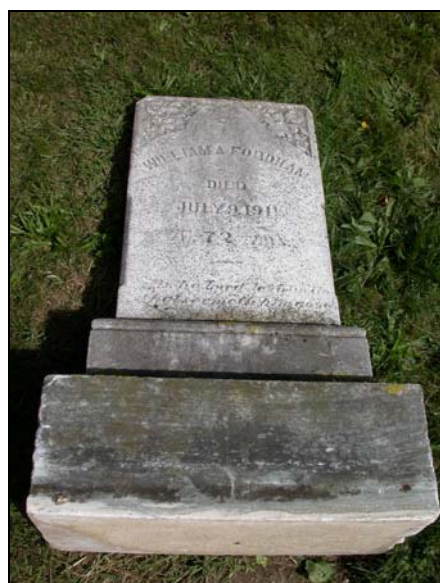
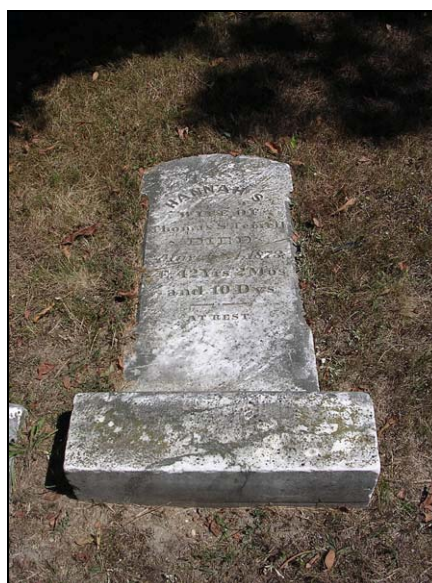
*Headstones in Base: Fallen and at Risk, SO1 #307, EQ1 #2140*

Another threatening, but not (yet) serious problem is that fact that many of the heavy base marble markers have been tipped over. Those without any damage should be put back into position by the Town maintenance crews. It is recommended that a monument company be consulted for additional ideas to place these monuments more deeply and securely into the ground. If these fallen markers are left in the tipped over position, they may soon become

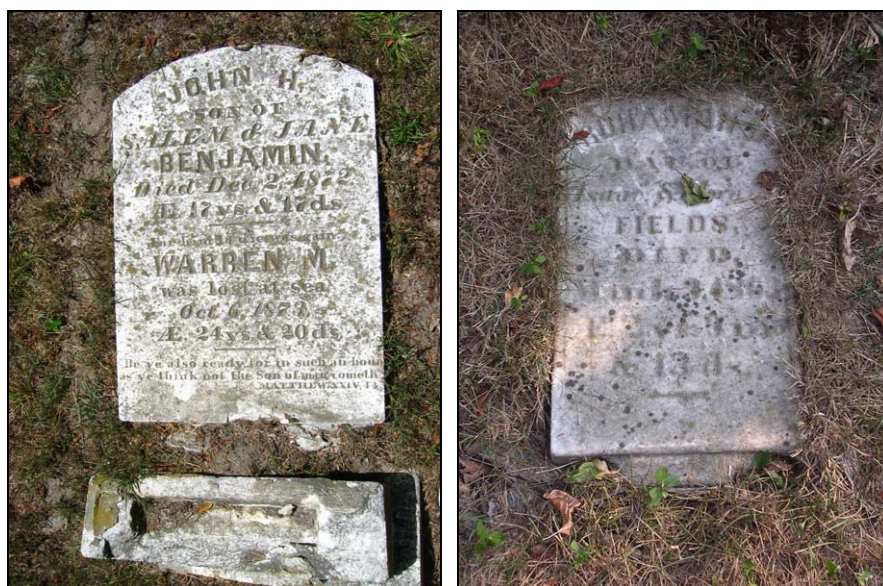
Another design fault of marble headstones in bases placed in the mid 1800s is that instead of keying a large portion of marble into the ground or into a base, only a 1.5-2” lip of marble is held in the base. There are examples of broken markers shown as disassembled and/or fragmented because of this design flaw, particularly at East Quogue and North Sea.

*Headstone in Base – Faulty Design, EQ1 #2113, #2021*

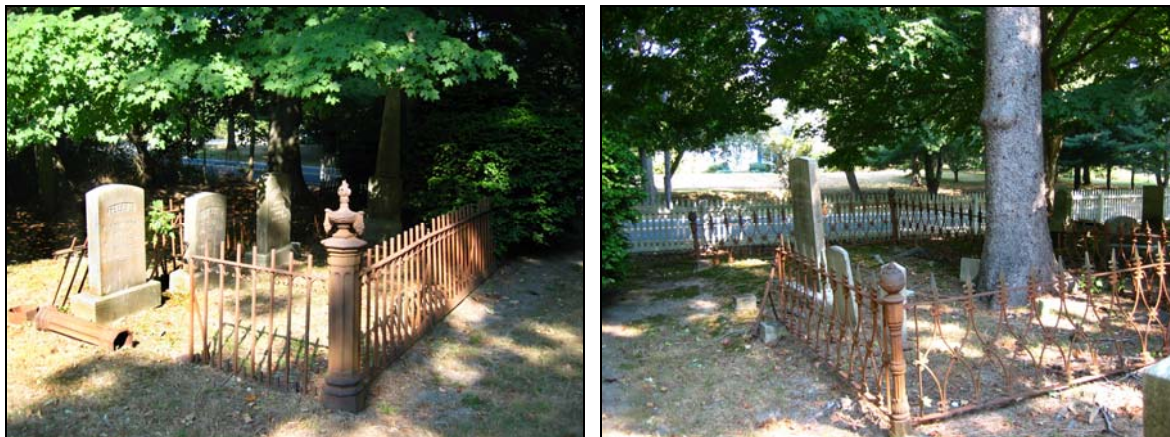
close proximity. Family plots marked out with enclosures became more common in the mid-1800s forward and there are several good examples at North Sea and East Quogue. There are serious condition problems with most of the metalwork that makes up the enclosures.

*The Rose Family and Cooper Family Plots at North Sea*

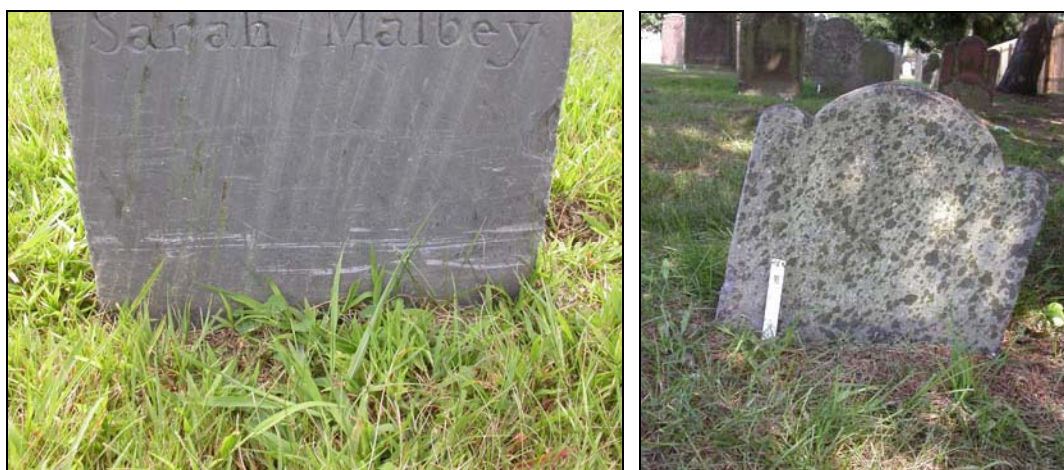
**Slate** – Most are in remarkably good condition. Carvings and inscriptions are sharp and very legible. The most prevalent condition noted is “buried”, where many are buried below where the bottom of the inscription or any carver signatures would be, but most “buried” are not rated as a 3 or 4. The most disturbing conditions are recent mower abrasion damage and bad staining along the fence line at the North End Burial Ground from an irresponsible application of clear-coat finish sprayed onto the new fence without any regard to the stones beyond. To remove these stains will take considerable time and skill by a stone conservator.

*Slate markers: SO2, #726 with mower abrasion and at SO1, #156 is partially buried and badly stained by recent fence ‘clear-coat’ spraying.*

A recent, and also quite serious problem, is the aggressive and careless mower scratches, spalls, scrapes, plastic abrasion marks, and actual loosening of many of the markers in the ground do to impact. The bright white scratches on the marble are evidence that much of this damage is recent. This is a training issue, costs no outside capital, and is something that can be addressed within the maintenance group and in instructions given to contractors. Sensitivity training should make the comparison of this resource to the home or the interior of a museum. In such environments, a heavy vacuum cleaner would be used on the empty floors or public corridors, but soft cloths and great care would be used to dust the collection. Maintenance workers need to understand that the reason to care for this site *is to protect the collection*, not to create a perfectly mowed lawn. That instruction should also have be given to all contractors working in and around the cemeteries, so that there is no a repeat of the problem at North End where the fence builders took no notice of the value of the collection they were fencing, as they used a spray gun to treat the new fence with a clear coat finish.

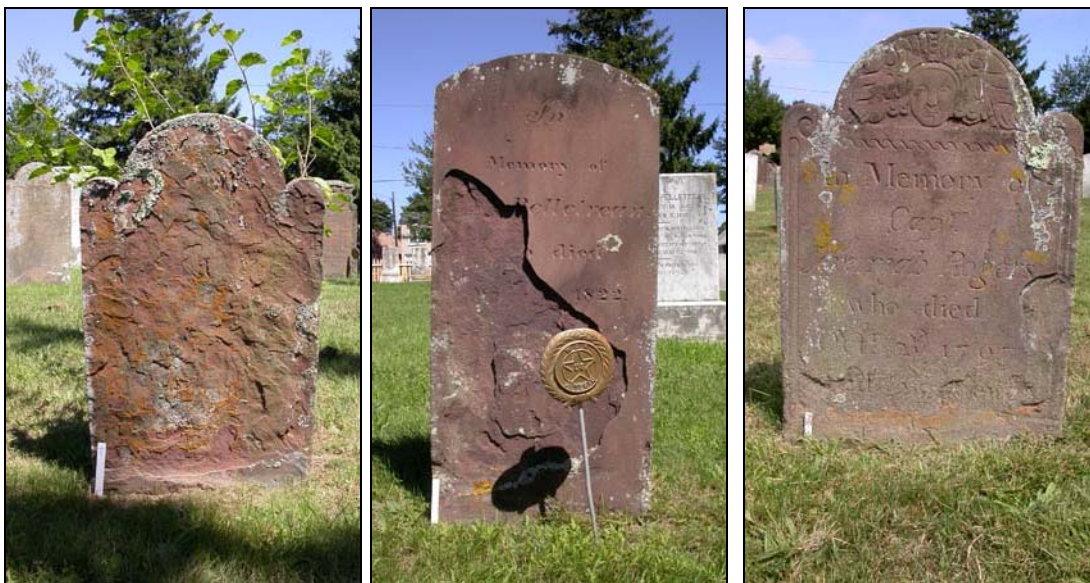
**Sandstone (Brownstone)** – This stone presents the most serious conditions. Sandstone is a sedimentary material, formed by layers of sand deposited and held under pressure over millions of years. Depending upon how well the layers fused, and how densely packed are the sand crystals, different stone properties result. Sandstone markers are often placed into the ground with the bedding layers perpendicular to the ground. Depending on the quality of the stone and on local conditions, water can cause the beds to delaminate and crack. A condition develops commonly called “blind delamination” where the carved face invisibly separates from the rest of the stone.<sup>7</sup> This is a very critical condition as these markers can lose their face from any impact, be it accidental or through rubbing or mowing. The markers noted with blind delamination are often examples of the earliest and most valuable marker art and these markers are at great risk. These should be the top priority for conservation funding. During the Community Workshop, conservator techniques to preserve these stones were shown and during the Phase III treatments, eight of the most serious at-risk markers were grouted and filled. (See Section V Treatments and the Treatment Reports in Appendix G)

*Blind delamination in Sandstone. Gone (left), Going (middle), Will go if hit (right)*

The survey of North End Burial Ground alerted the project managers to the fact that there were very rare, very fragile brownstone markers with severe delamination, defined as detachment in the survey. It was agreed that during Phase III, demonstration treatments would focus primarily on these at-risk markers. In this way, methodology could be developed for future conservators, and the emergency condition markers would be stabilized.

A majority of the Phase III field work time was spent on the treatment and repair of emergency condition markers based on the Phase II survey results. Frank Matero spent the first week of the session to carefully supervise and train the interns and another (unpaid) graduate intern assisted. Additional cleaning of markers that had been partially treated in the Fall 2004 Public Workshop was also completed.

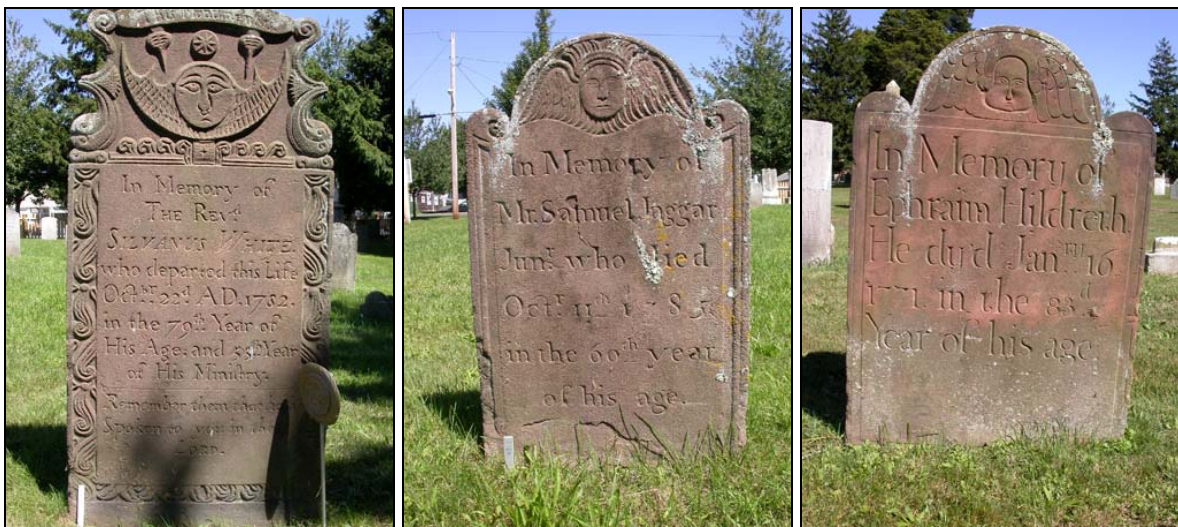
Examples of carving styles found on Sandstones at North End Burying Ground. The far right is believed to be carved by the well-known carver, John Zuricher. For more information on the carving styles found in Long Island cemeteries, see Richard F. Welch, *The Gravestones of Early Long Island*, 1983.

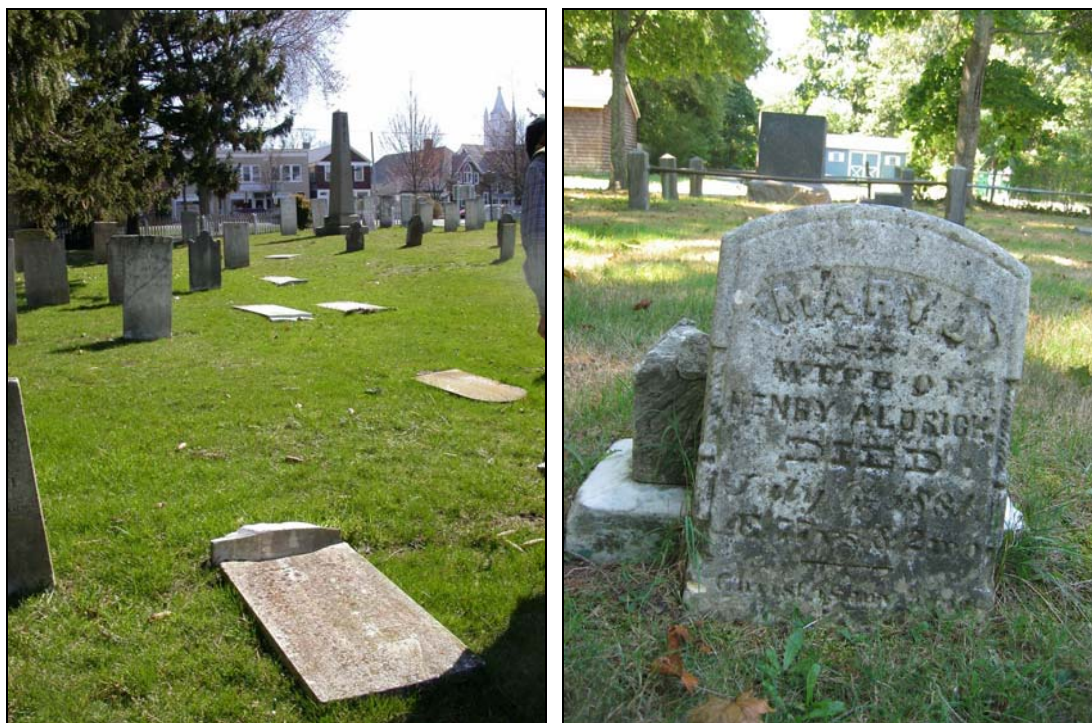
**Marble** – The marble markers are generally pretty well eroded at all sites, but there is no active sugaring or disaggregation taking place. The erosion seems to be stable. Most of the marble is heavily covered in mold and many also show considerable lichen growth. Many are also tilted or fallen and there are many fragmentation breaks occurring because of falls, vandalism and other environmental and man-made impacts.<sup>8</sup>. Over time, the thin marble markers have become vulnerable from wetting and drying. The North End Burial Ground was vandalized in early April 2004 and many of the marble markers were easily broken at the base and there are signs that vandalism may also have occurred in the past at both North Sea and East Quogue.

*Recent vandalism (April 2004) at North End left a swath of destruction. The older markers were buried deep in the ground and broke just above ground level. Those embedded in bases broke just above the base. To the right, heavy biogrowth on a marble marker under tree cover at East Quogue.*

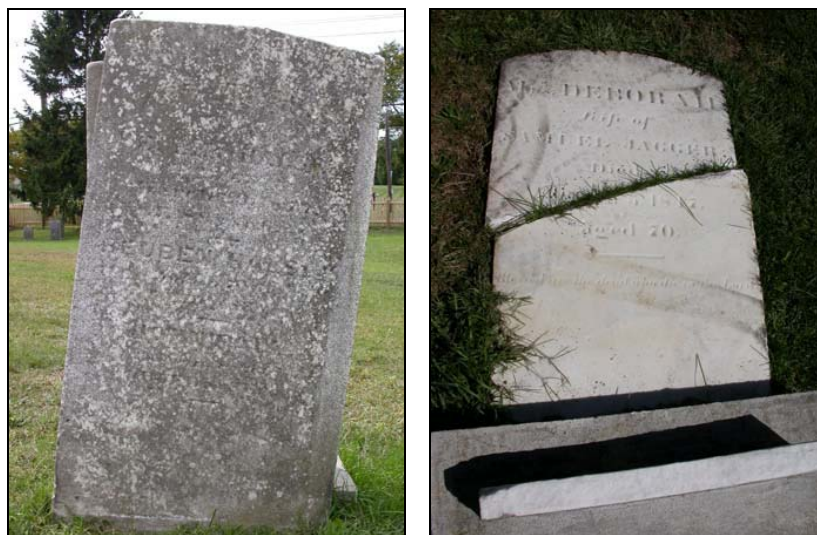
will be an expensive undertaking. Of 828 primary marble markers surveyed, 115 showed some fragmentation with no loss and 79 showed fragmentation with loss. Some of these markers had both conditions, so these numbers are not additive, but there are at least 135 markers rated as a 3 or 4 for one of the fragmentation conditions and represent marble markers needing attention.

*Mold, highly eroded, tilted (left), Recent vandalism breaks (right)*

At most of the sites, fragmentation with and without loss is a major problem. It is estimated that over 135 marble markers are broken in some manner. Those that are fragmented without loss should be addressed as a priority, as the marker pieces are still intact. The large number and the break severity on this class of problem will be an expensive treatment category and one that

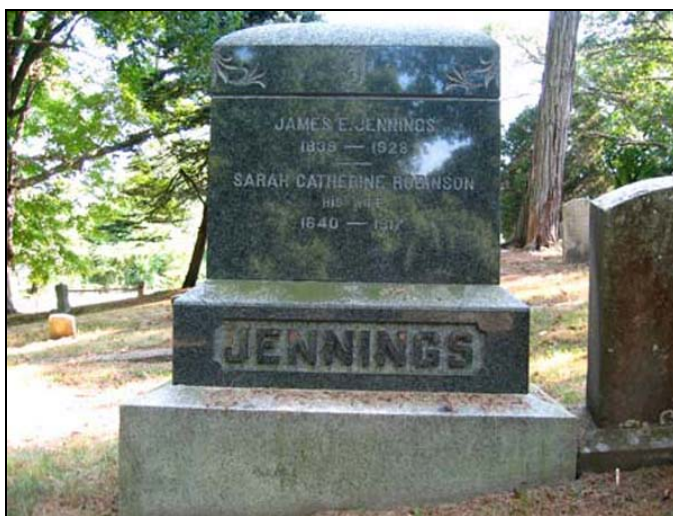
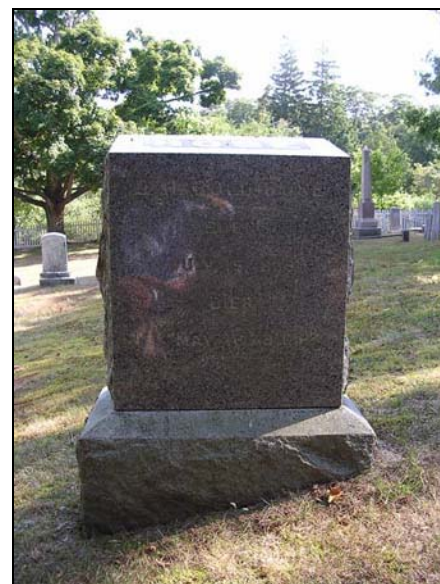
*NS1, #3068 with biogrowth. NS1, #3101 with exposed foundation*

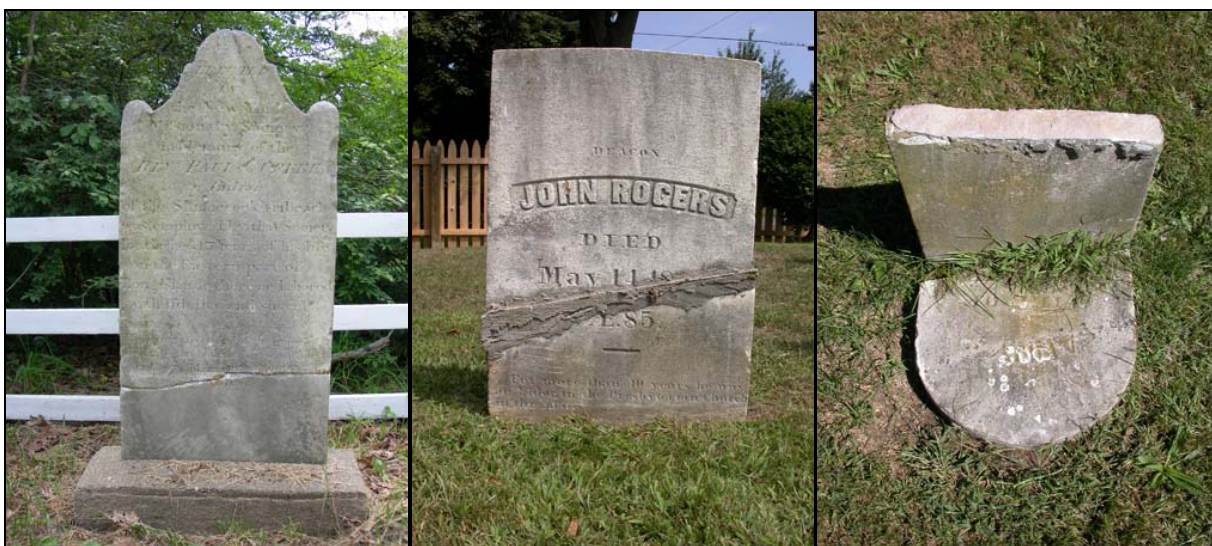
For all materials, there have been past attempts to repair broken monuments. Some of the repairs were done well, and some are very damaging and unsightly. Heavy cement repairs were made in some cases, and the cement was smeared across the monument face, obscuring the inscription. A good number of epoxy repairs can be seen where the epoxy material has broken down and the repair has failed. It does not appear that any of the past repaired breaks were made with pinning techniques to provide the structural strength needed to survive long-term outdoor exposure to man and elements. An example of marble ceramic pinning was made during the Community Workshop to demonstrate the technique. Very fine gauge ceramic insert pins can also be used to re-attach carved face details in a blind delamination sandstone repair.

*Rev. Paul Cuffee Gravesite: A good repair, At North End, example of cement repair and a failed repair.*

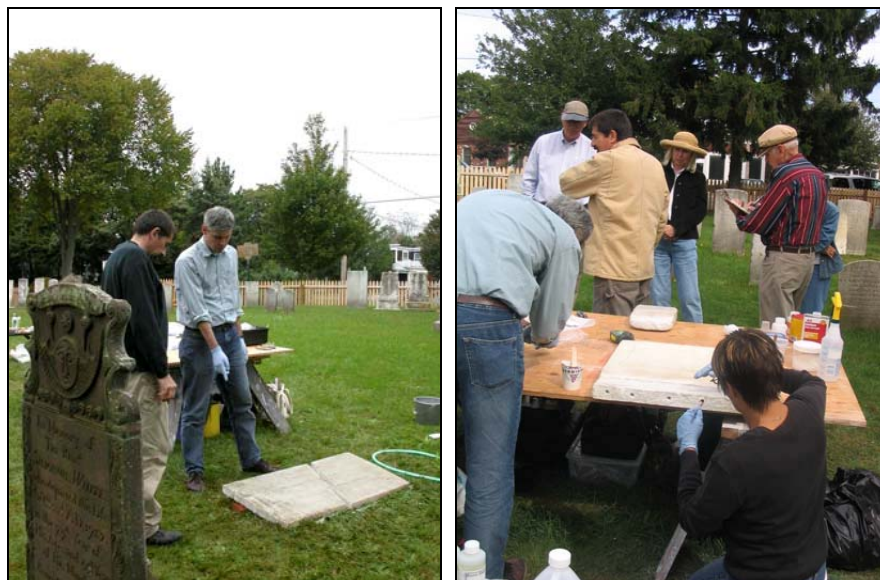
*Below, demonstration of marble pinning during the October 2004 Community Workshop.*

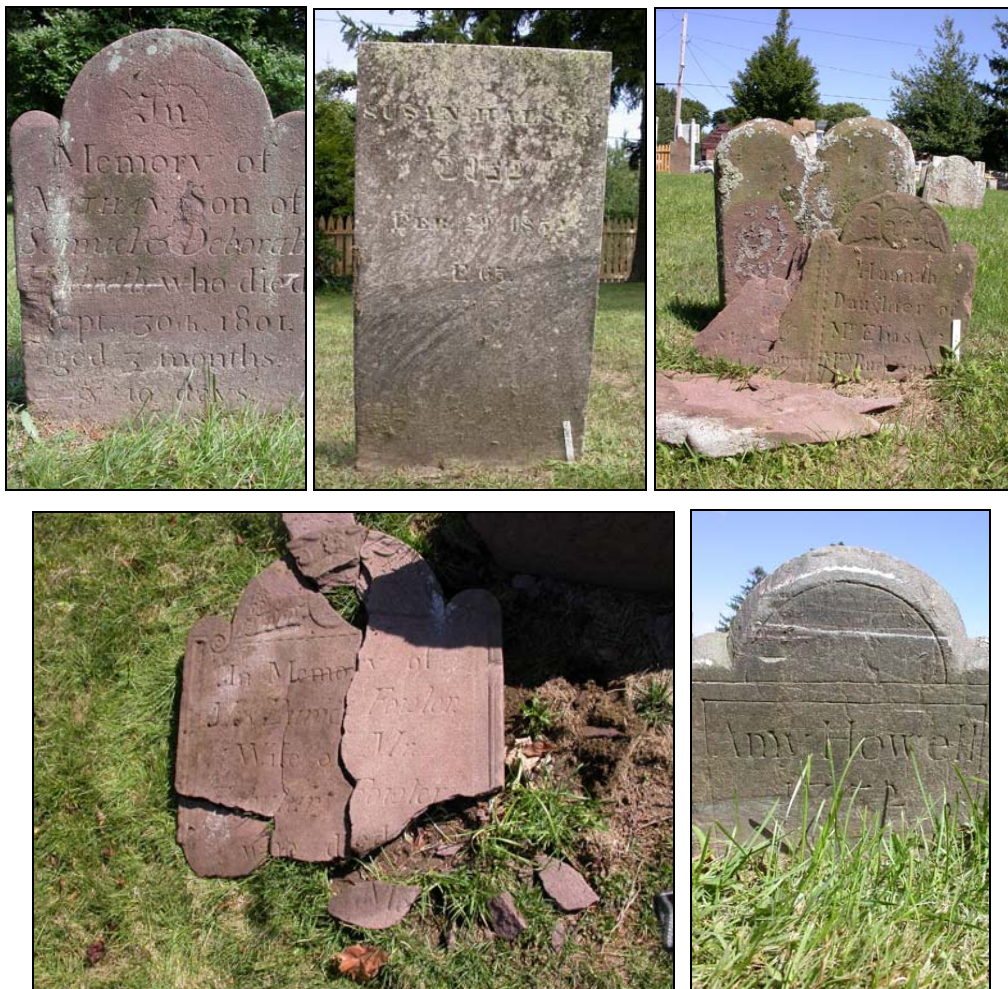
**Mower Abrasion:** Conditions that were very prevalent across all materials particularly at the Phase II three sites surveyed were “mower abrasion” and “spalling” which was generally due to aggressive maintenance and mowing. At North End, 41% of the features were rated 2 or higher for Mower Damage and at Noyac 46% of the features were so rated. Several markers show unsightly black marks at the lower edges where the mover tires have scuffed that close to the marker or at the top of the marker where plastic has become embedded in the face from scratches made by the grass collection bins. Colored weed ‘whacker’ plastic string material was also found on markers. Several markers that now are in a face-down position have obvious tire marks where the mowers have driven over the fragile stone material. And several of the sandstone, once valuable, highly carved works of art are now reduced to irreparable fragments due to being hit or impacted by aggressive actions.

*Different examples of mower abrasion*

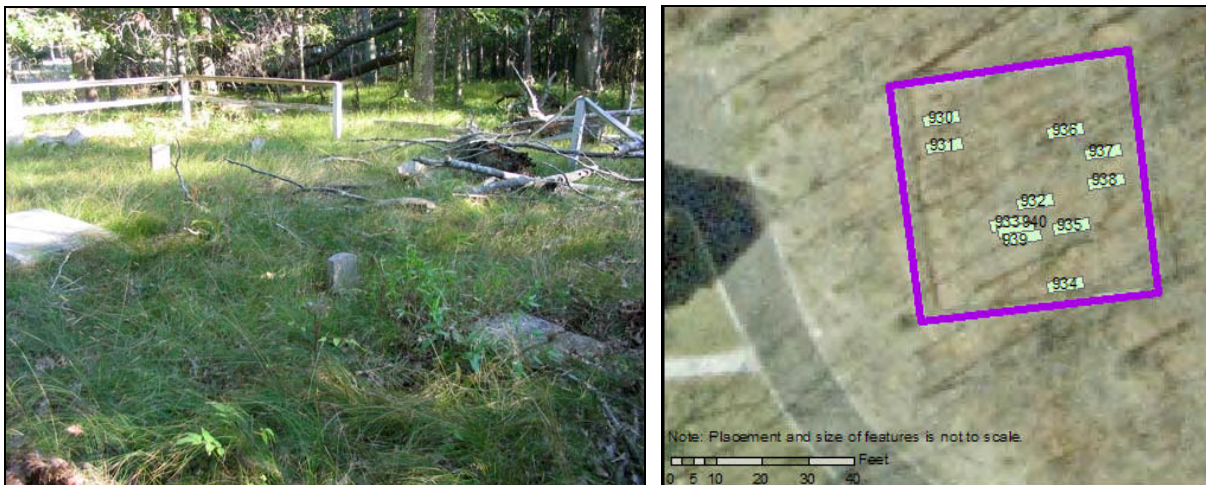
**Landscape Integrity:** The integrity of the landscapes varies between sites. Hubbard and Pleasure Woods have so much marker damage and so many markers have been moved, that without the fence enclosure, the sites would not be obvious. The Rev. Paul Cuffee Gravesite in the only remaining marker of what is believed to have been a larger cemetery.

*Broken markers and fence at Hubbard Cemetery. Digital ortho photographs of Pleasure Woods.*

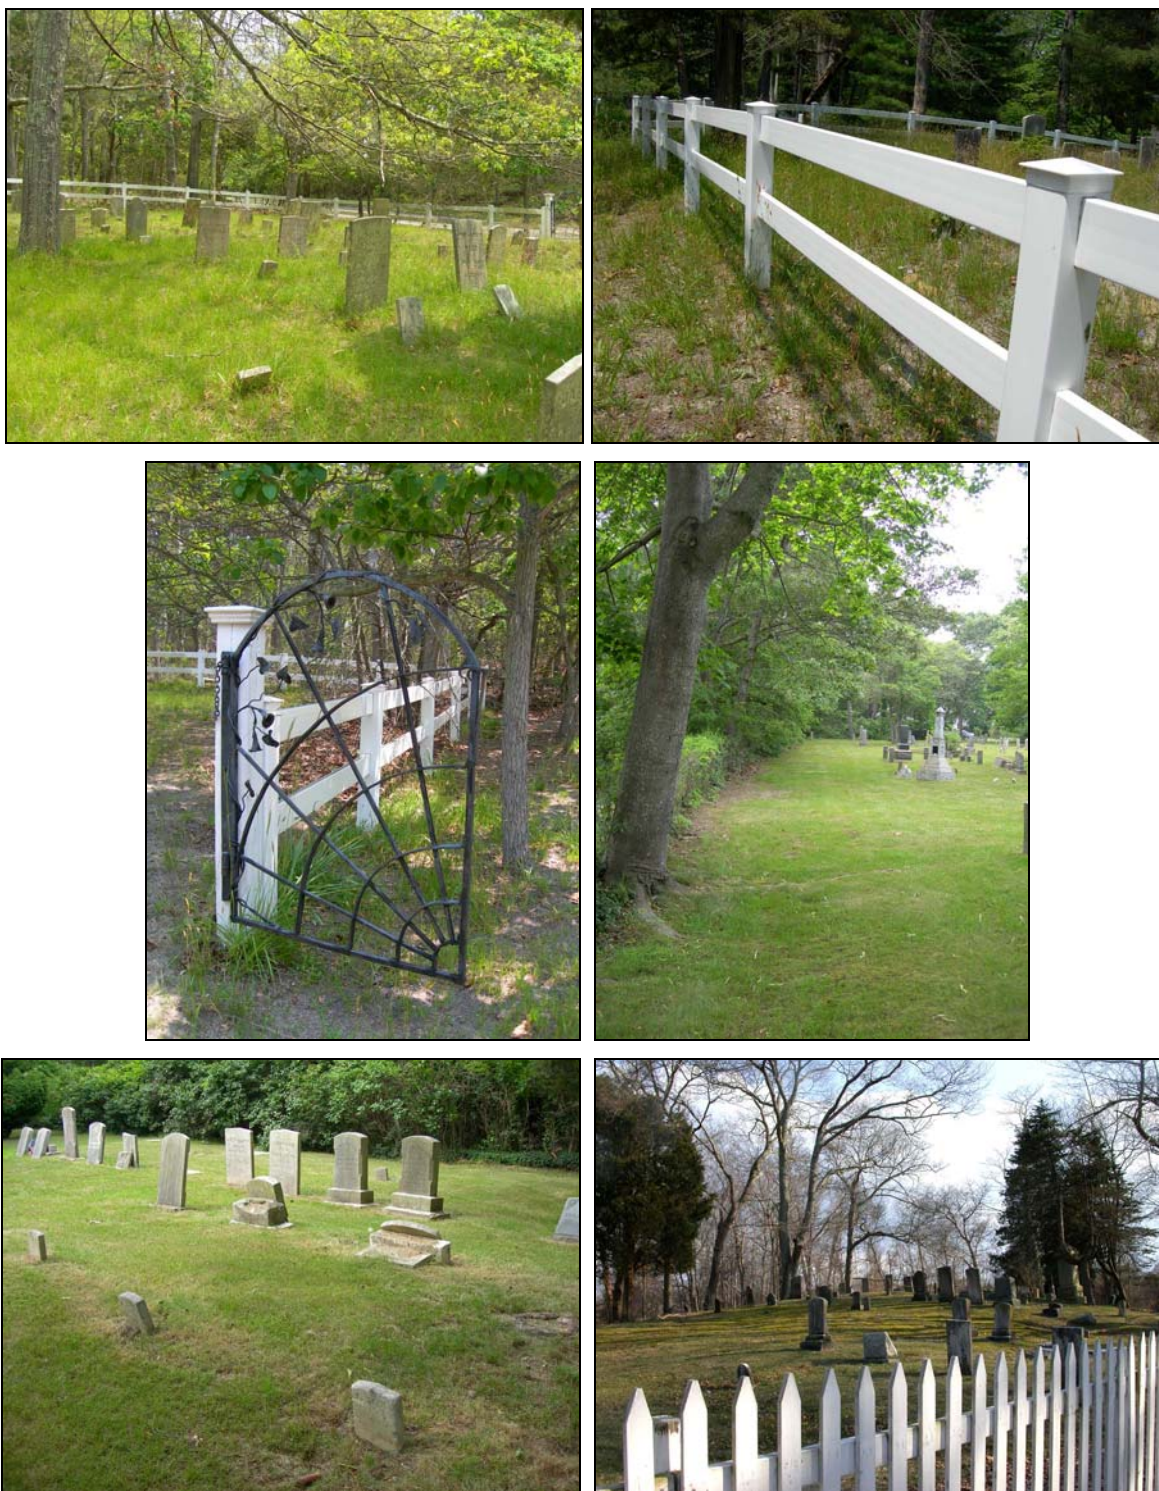
The integrity of the landscape at Squires Burying Ground, East Quogue and North Sea remains very high, and North End is also high with the exception noted below. At Squires, the only element to mar the integrity is the plastic fence surrounding the property which should be

replaced. The artistic gate leading into the site is not original, or indicative of the time period of the site. However, as an artistic piece presumably designed/donated by a resident, it could be noted as such, and still contribute to the site.

*Right to left, top to bottom: Landscape, Fence and Gate at Squires Cemetery, Boundary path maintained at East Quogue, Row of markers against old growth lilac bushes at East Quogue, Hilly landscape of North Sea.*

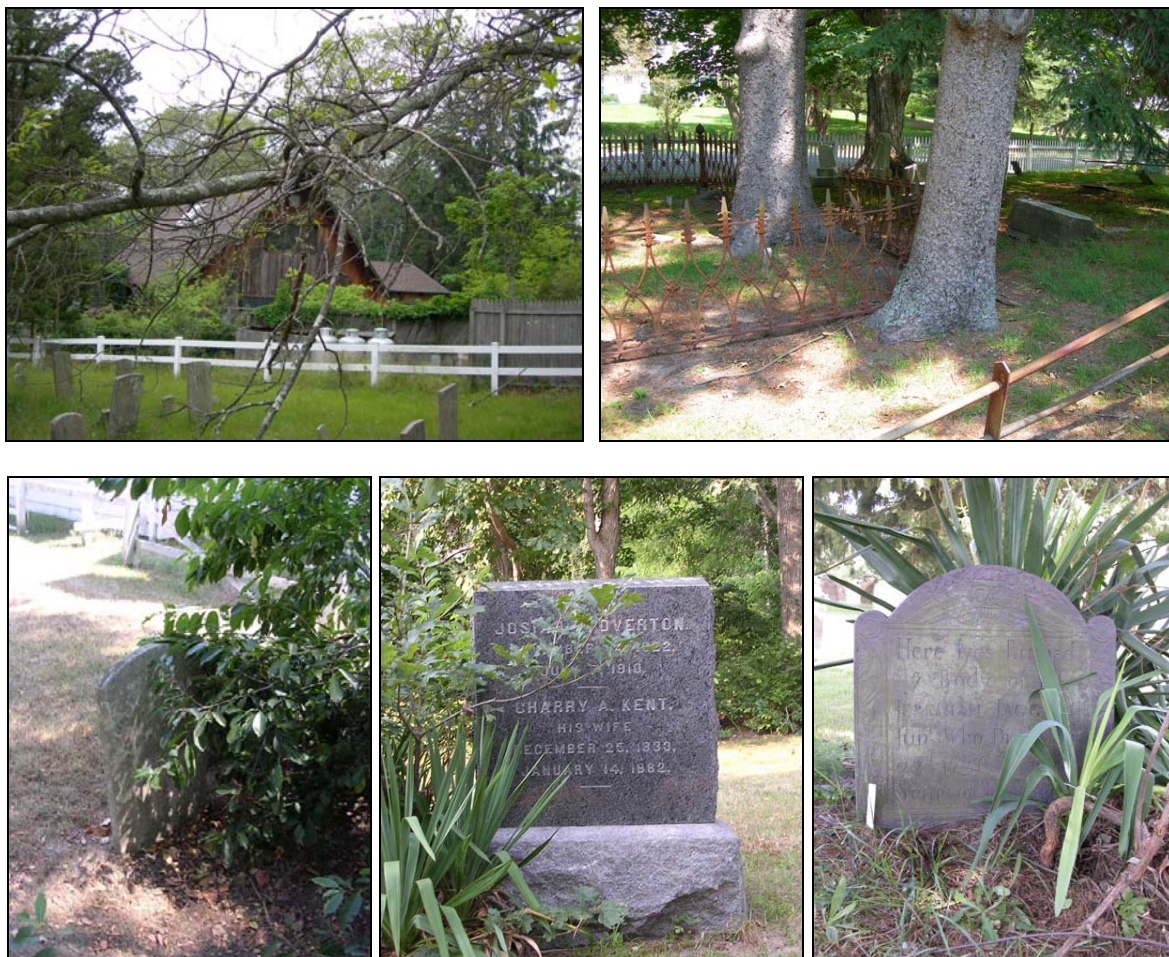
The conditions of landscape elements at all sites except for Old Southampton Burying Ground need attention, although it is evident that some good tree removal decisions have been made at sites like East Quogue and Westhampton Churchyard. At many of the sites, the cedars, once planted to memorialize the dead, have grown too large and now crowd out nearby markers, and there are also large deciduous trees and different types of shrubbery that have become a

problem. There are multiple cases of a yucca type plant that must have been a popular local planting for gravesites at one time. These have grown very large and are disrupting marker foundations and in most cases, should be removed.

*Top to bottom, left to right: Dead Limbs at Squires threaten markers, Large cedars compromise the Cooper Family Plot at North Sea, Overgrown shrub at Westhampton encroaches marker, Yucca plant at East Quogue and North End impacts foundations.*

The landscape needs are next most pressing, as many of the large trees threaten the markers and damage caused by falling tree limbs or large roots can be seen in several of the sites.

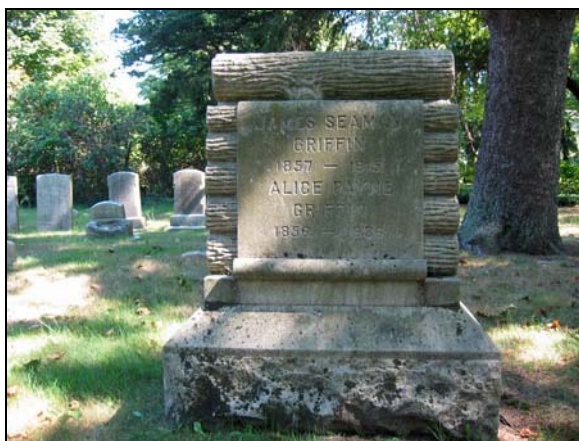
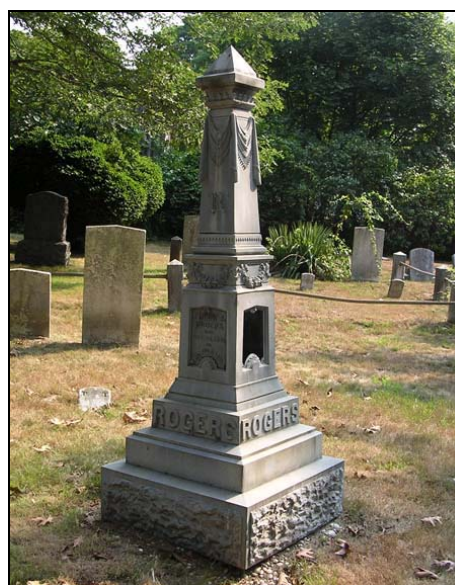
*Both at East Quogue, #2066 is an example of cast stone, #2098 is a fine example of the white zinc Pediment styles that were offered through specialized monument companies beginning in the late 1800s.*

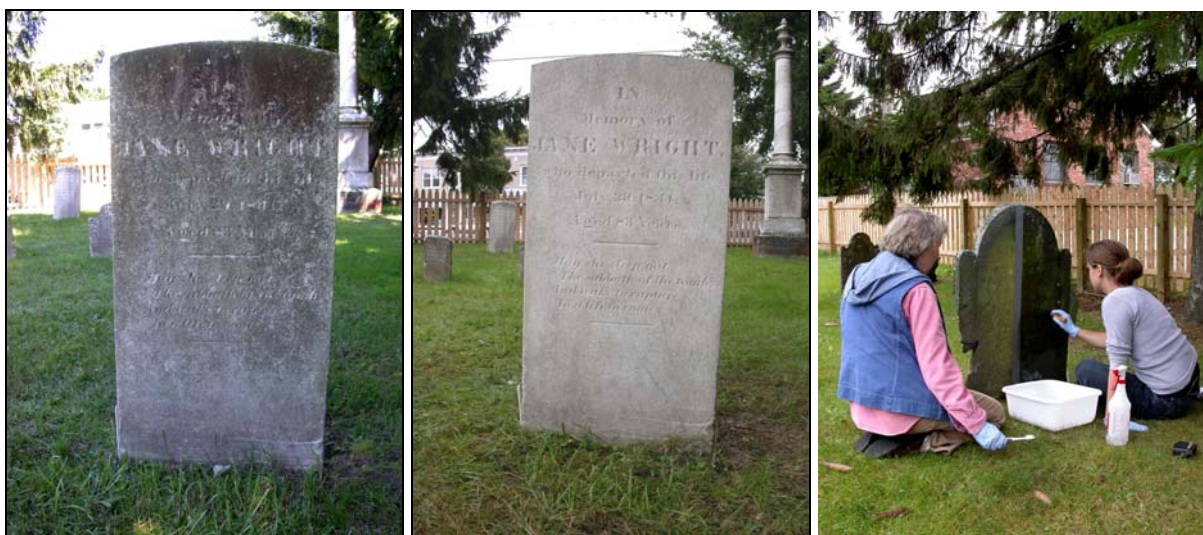
The most gentle, and first recommended, cleaning solution is plain water with a soft to medium natural bristle or nylon brush, starting from bottom up to loosen the bio-growth and remove any superficial soiling. Much of the lichen can be removed in this manner once softened with water. Soft wooden sticks can be used where the stone is strong enough. As many of the aged markers are delicate and brittle, only very gentle brushing/scraping actions can be used. To remove the mold from marble, a successful treatment involved cleaning first with water and detergent using a nylon brush. A poultice containing a 5% solution of calcium hypochlorite was then applied with a dwell time of 1 hour before rinsing with water. The brownstones were cleaned with a dilute ammonia solution after softening and partial remove of lichen with water. A dilute ammonia solution poultice can also be used overnight aggressive lichen growths.

North End Workshop: #031 marble marker before and after cleaning, #119 slate being cleaned.

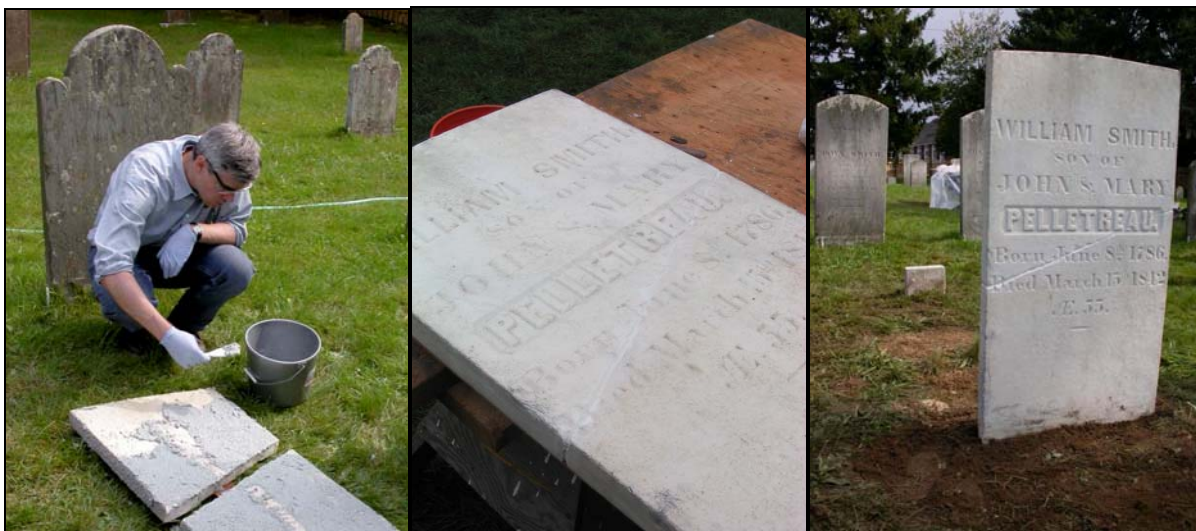
*Preparing #130, applying a poultice, the pinned marker, then the reburied marker and footstone.*

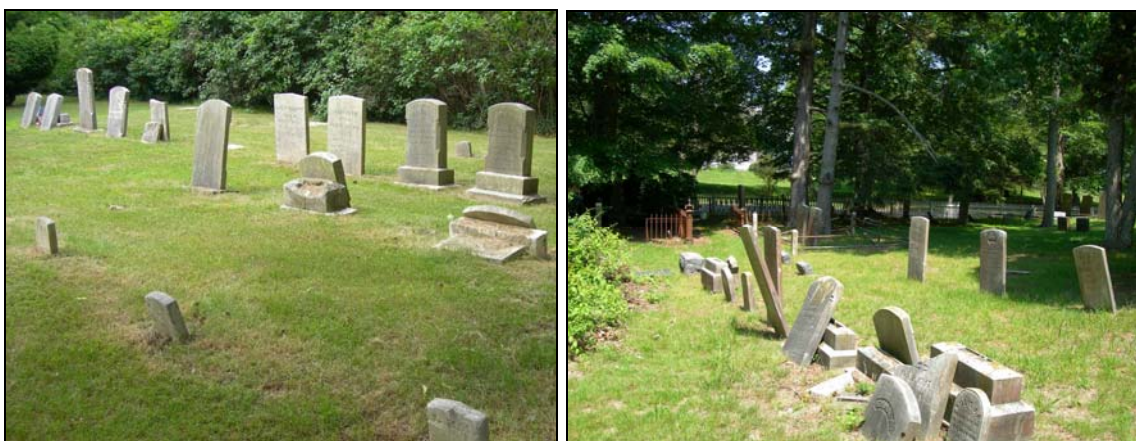
*Broken Rows at East Quogue (left) and North Sea (right)*

will need careful planning. It may be advisable to put some of the fragments into storage so that they don't get further damaged or misplaced before conservation.
