A Report on the Ground Penetrating Radar Survey 205 Little Plains Road Southampton, NY

November 18, 2016

Conducted by Robert W. Perry TOPOGRAPHIX, LLC Hudson, NH

Subject: GPR report – Southampton Historical Burial Grounds

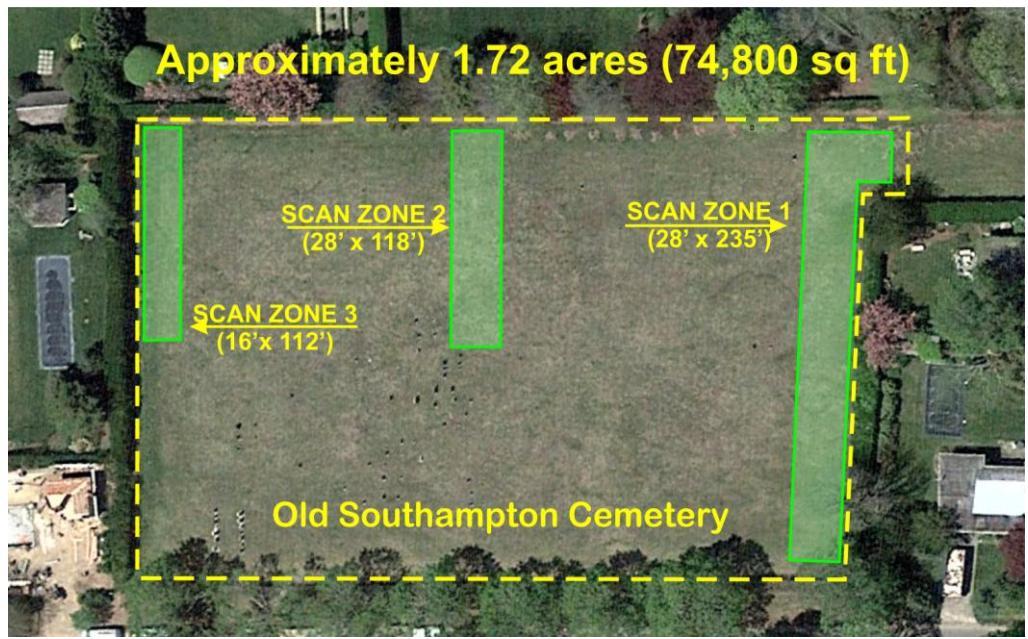
At your request a Ground Penetrating Radar (GPR) survey was performed at the Southampton Historical Burial Grounds located at 205 Little Plains Road, Southampton, NY. The GPR survey was done to try and locate unmarked human graves on a parcel of land with open grassy terrain approximately 1.72 acre in size. Three Scan Zones (CZ) were set up for exploratory scanning to determine the presence of unmarked graves. The exploratory scanning was to also determine the population of graves within a given length and width of ground distance if graves were discovered.

Figure 1: Shows the location of 3 Scan Zones (CZ) and ground distance.

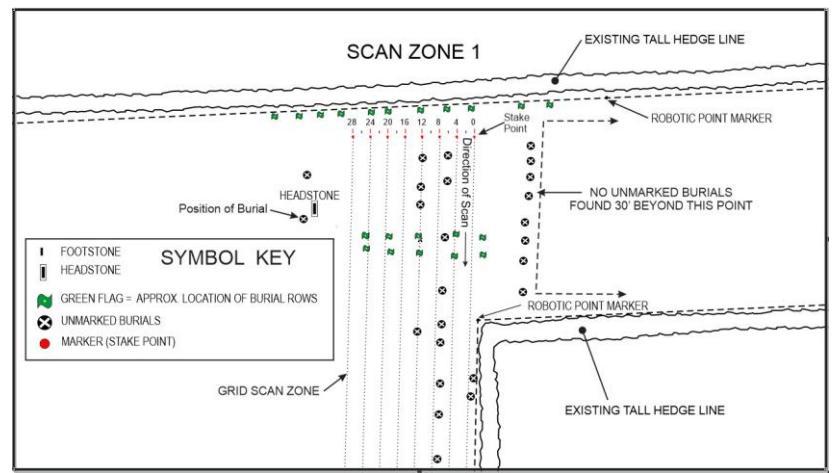
The second type of scanning was a grid scan where scan lines are laid down and GPR data was collected and analyzed using interactive 3D module software called RADAN. Figure 2 below shows a typical layout of scan lines and direction. The total ground area scanned for each Scan Zone (SZ) was as follows: $SZ1 = 28' \times 235'$, $SZ2 = 28' \times 118$ and $SZ3 = 16' \times 112'$. Scanning was performed in a north-south direction, starting with the northeast corner of each scan zone marked on the RMA as "Stake Point".

Figure 2: A section view of the attached GPR Survey Map

Ground stakes were placed 4' apart x's the length of the scan area at both ends making up a grid zone. Guide lines were laid down and looped around each ground stake running the length of the scan area setting up a straight line for grid scanning. The grid area was set up in the direction based on the likelihood that any burial holes being perpendicular to existing headstones. The X axis determines the width and the Y axis determines the length of the grid area as seen in the attached RAM.

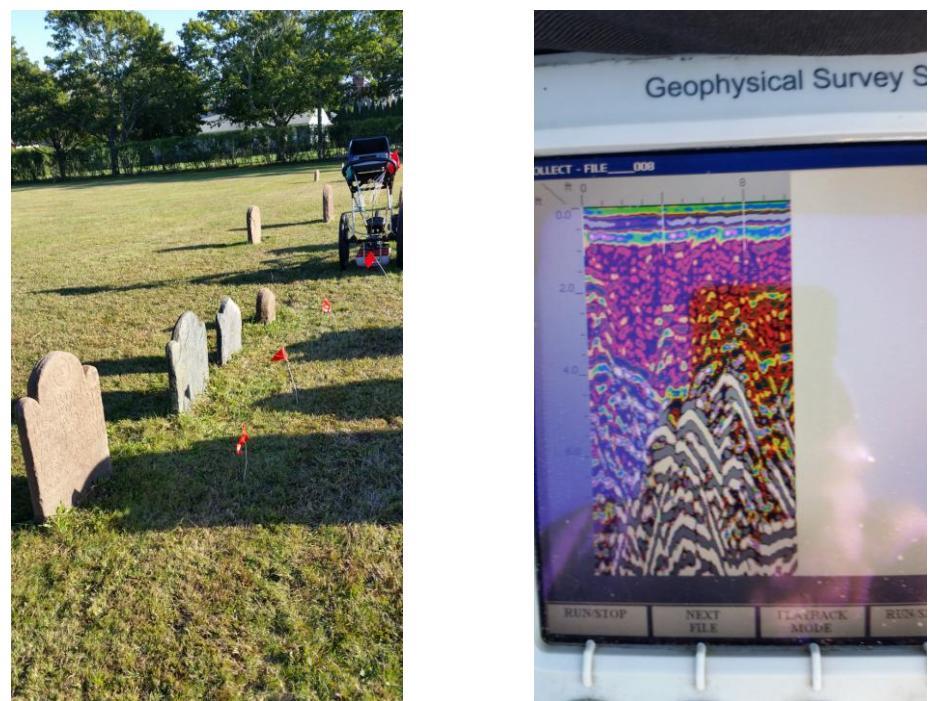
To survey the hyperbolic characteristics and soil conditions from known grave sites, a test area with dated headstones were selected for scanning. The test scan provides a visual reference for the type of anomalies and soil conditions for the area.

Figure 3: Test scanning of 3 headstones with radar anomalies showing 3 graves

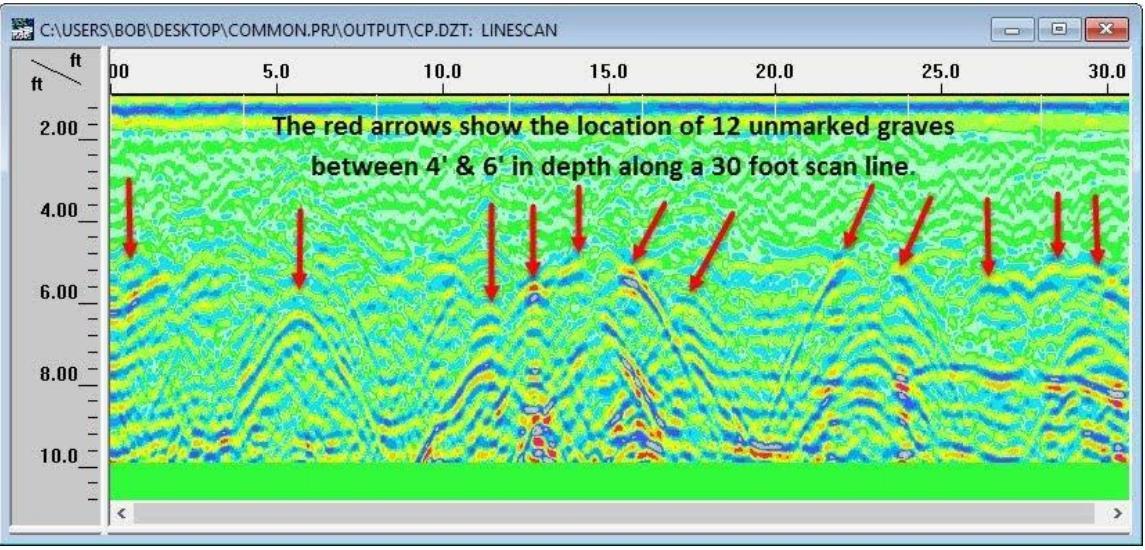
A second test site was selected for scanning in an open area where ground-penetrating radar revealed 12 subsurface anomalies over a distance of 30 feet at a penetration depth of 10 feet, were of good interpretative quality.

Figure 4: Profile image of 12 unmarked graves

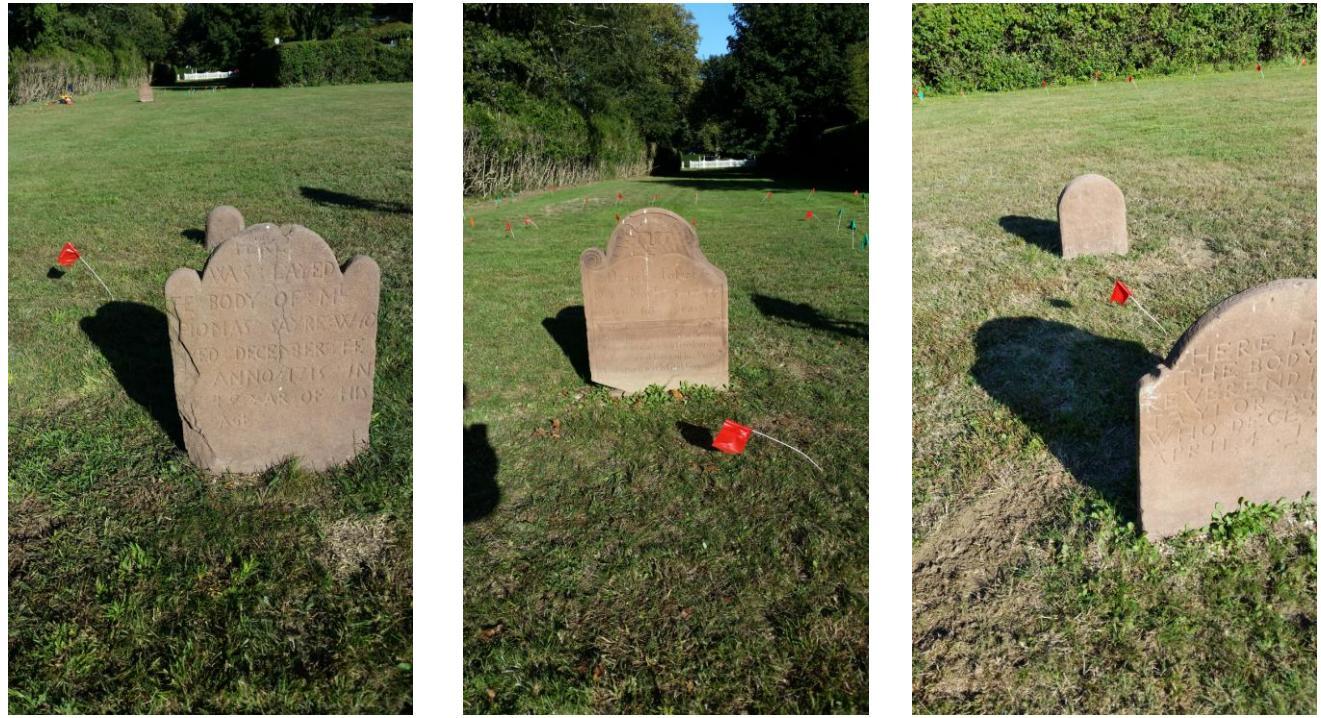
While performing exploratory scanning of marked gravesites, it was noted that many of the graves did not line up with the position of the headstones indicating that the head/foot stones at one point may have been moved or relocated from a different area. The close proximity of unmarked graves would provide an explanation for misalignment.

Figure 5: Red flags indicating the position of the graves to the headstone positions.

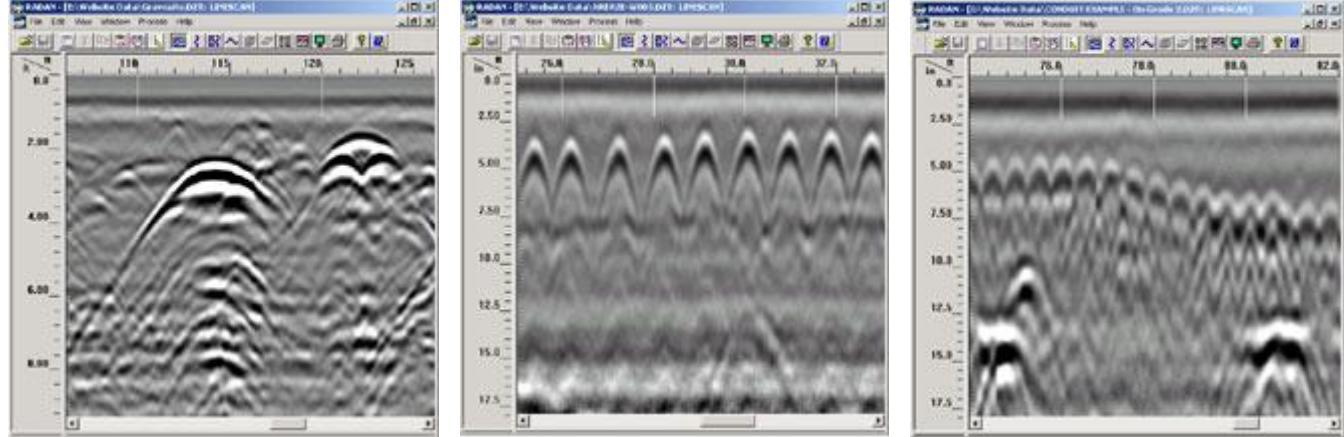
The examples shown below are presented for informational use only. The examples illustrate how a single ground-penetrating radar scan along a survey line can reveal a unique hyperbolic (curve) characteristic of each of the targeted objects. Vertical scales include Time (ns) or Depth (ft/m) as well as horizontal scale for ground distance viewed at the top of the images.

Graves (Coffin)

Rebar

Conduits

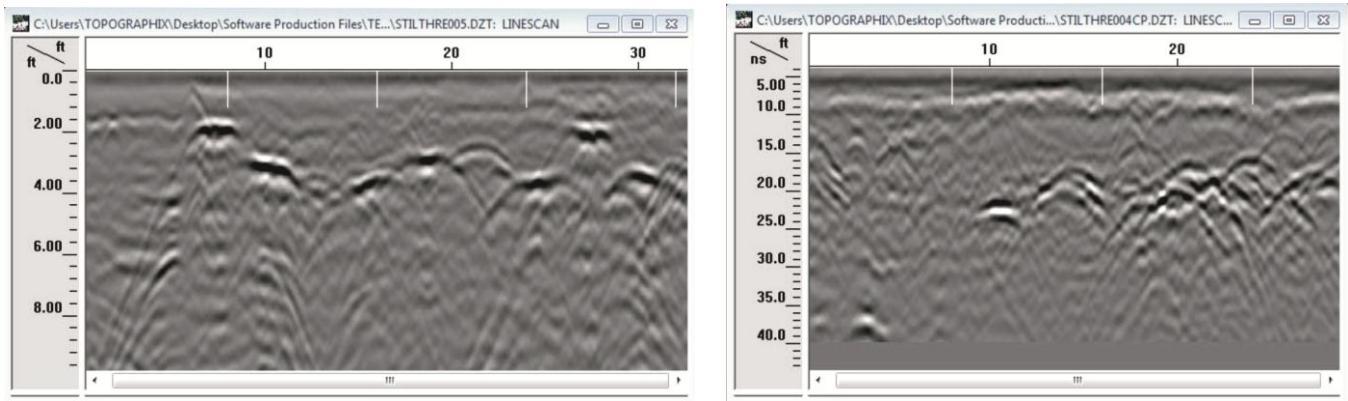
Burial Vaults

Graves Late 1800s

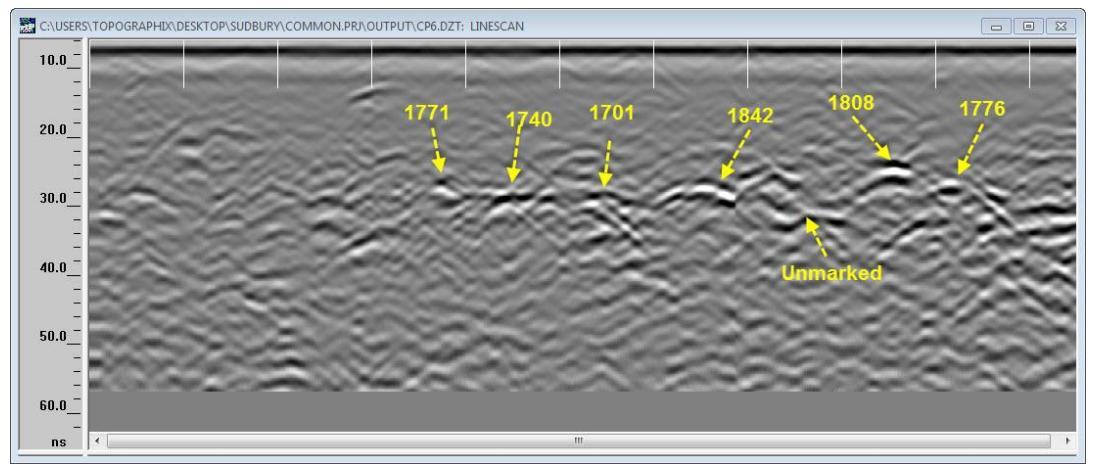
Scan Image of the Six Dated Graves with One Unmarked Anomaly (Revolutionary Cemetery)

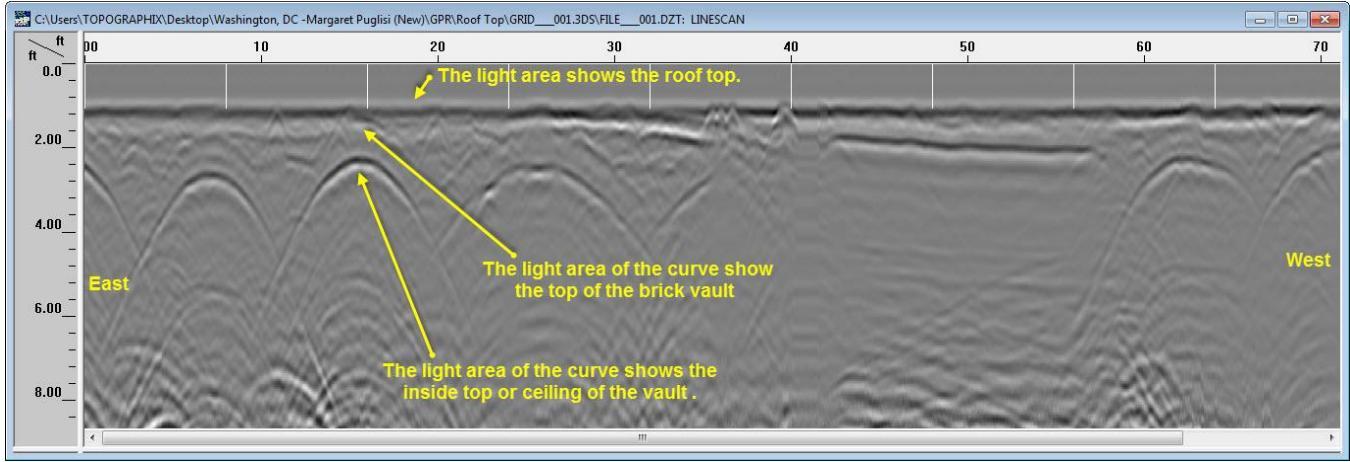
Scan Image shows the roof tops of eight above ground burial vaults along a cemetery roads way
