Restoration at Southampton's Old Burying Ground,
Southampton Sept 25th – Oct 4, 2015

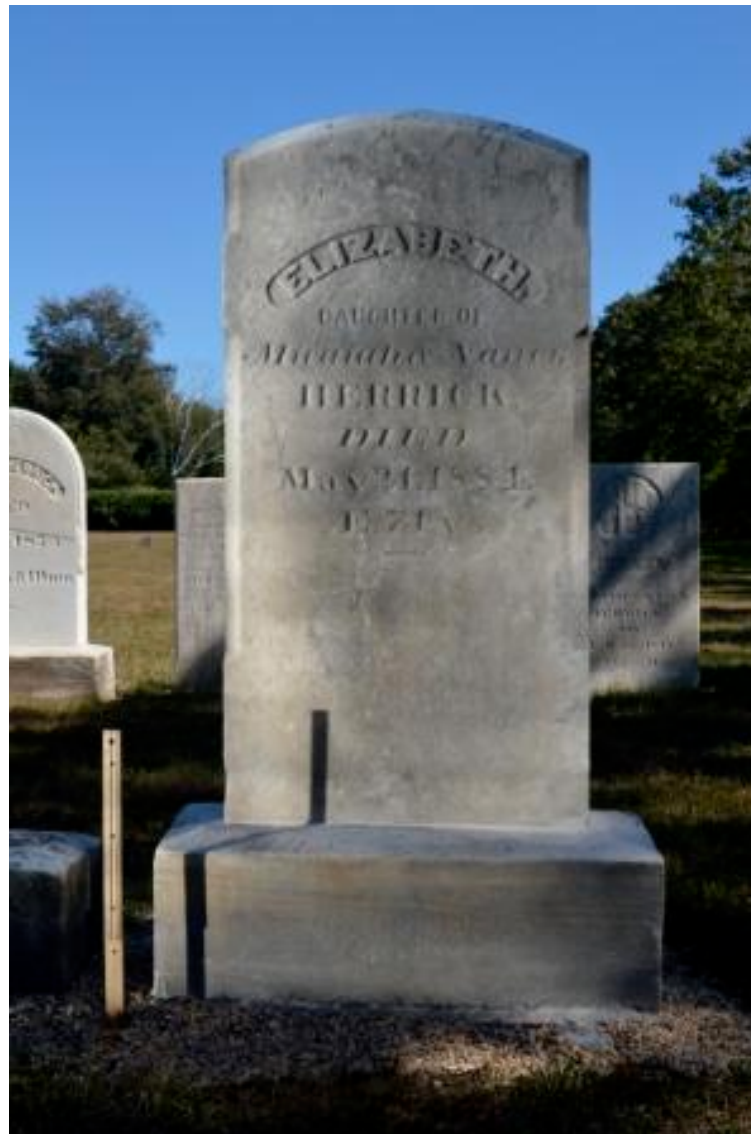
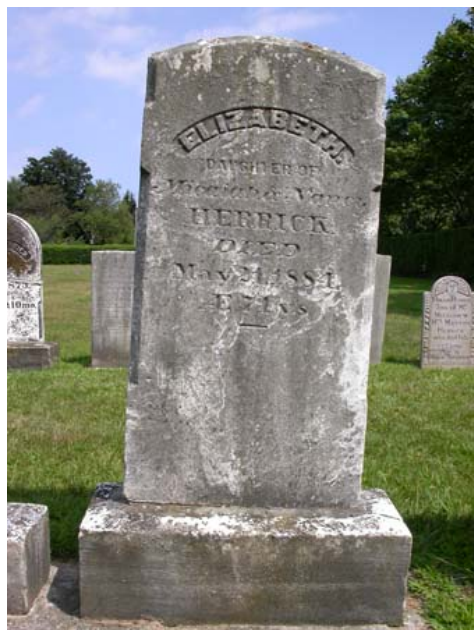
#703- ELIZABETH HERRICK d. 1884

Condition
in 2006
U of Penna

9/25/2015: CONCRETE CUT FROM PEDESTAL

9/26/2015: HEADSTONE RAISED AND SET

9/27/2015: MORTAR ADDED TO HEADSTONE

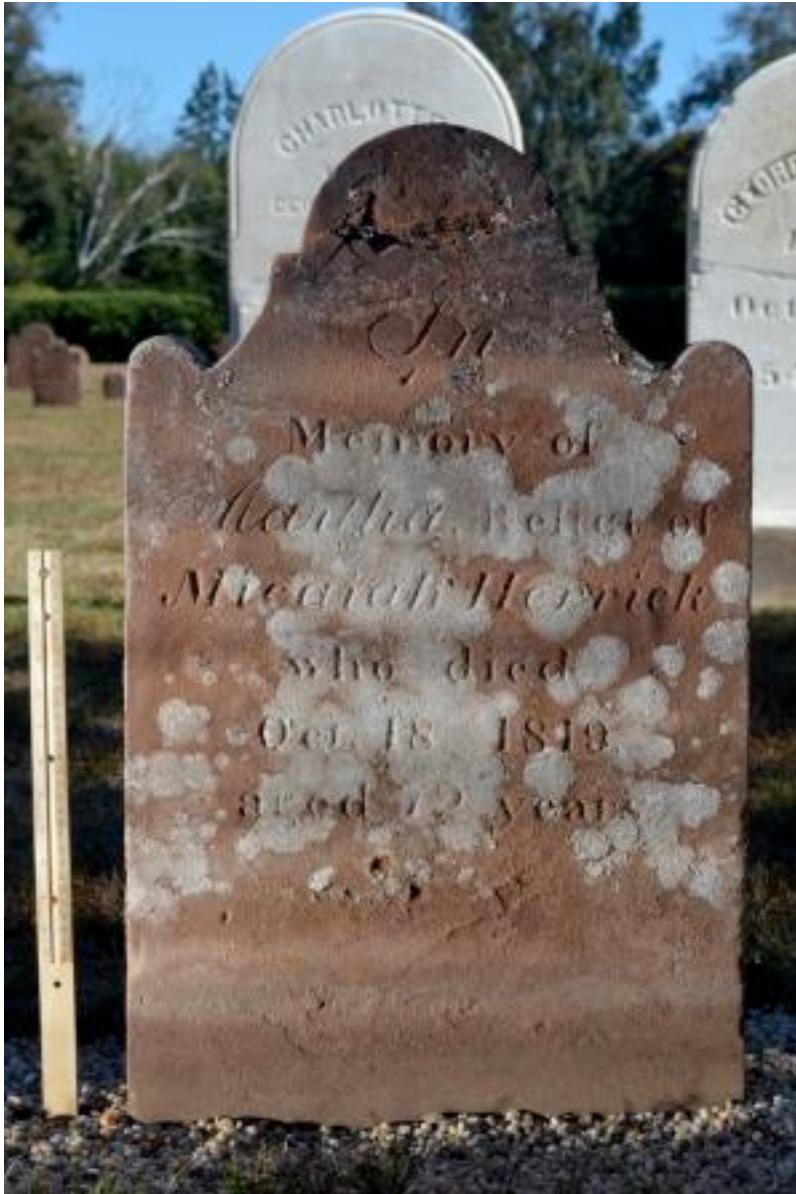
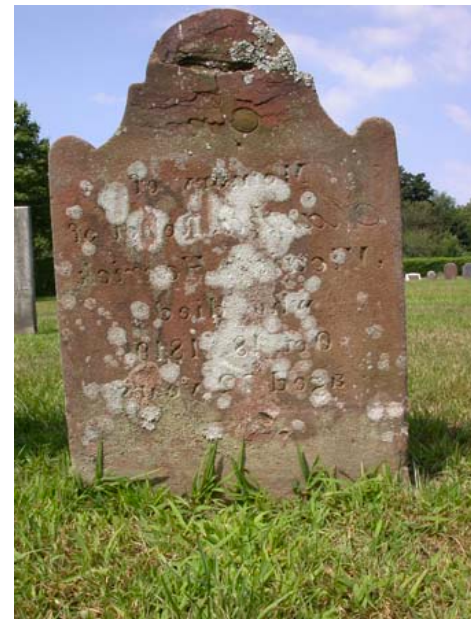
#706 – Martha Herrick, D. 1819

Condition
in 2006
U of Penna

9/24/15: The Headstone was straightened

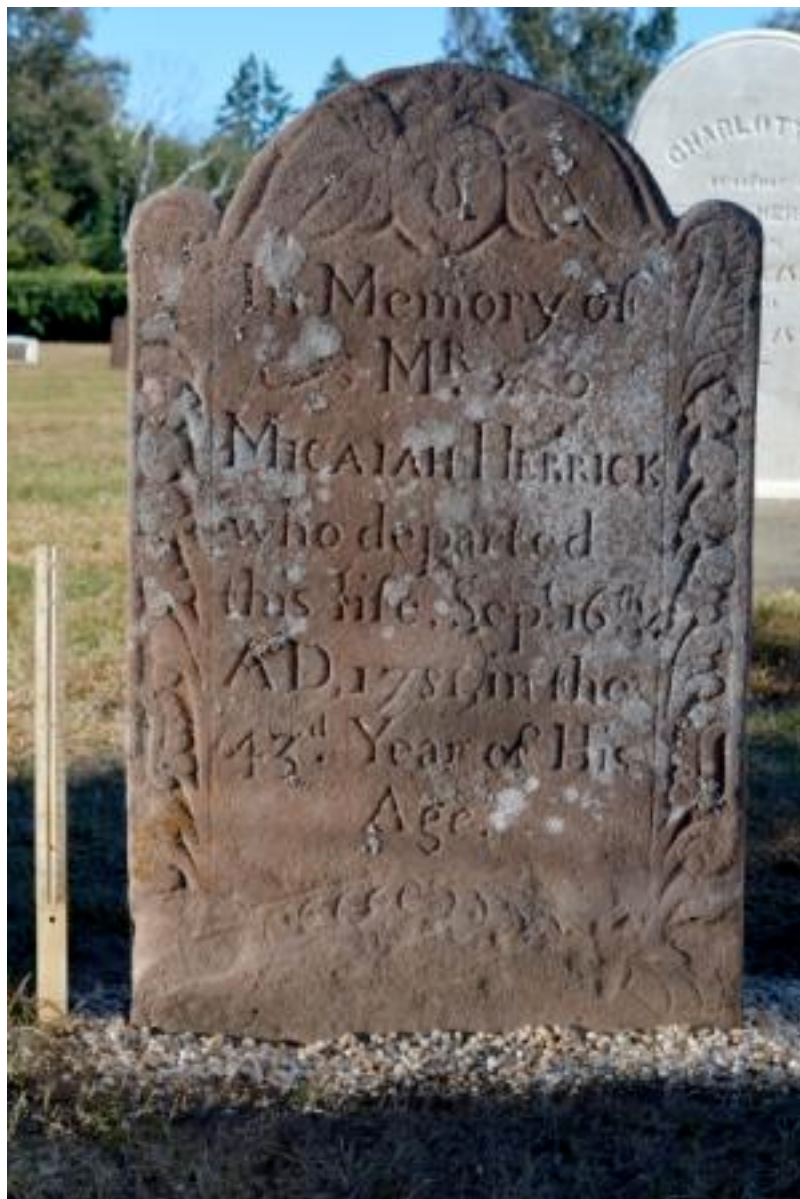
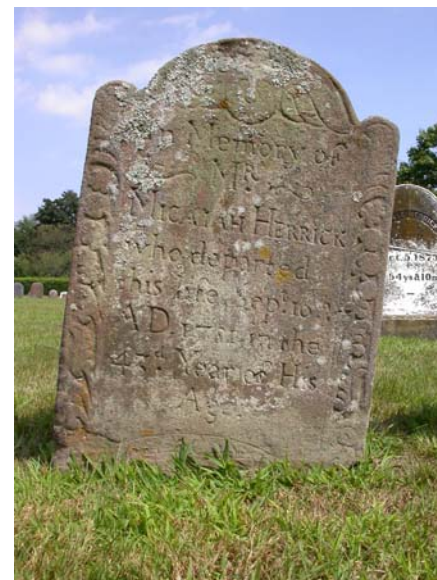
#707 – Micaiah Herrick D. 1781

Condition in
2006

U of Penna

9/24/2015: Headstone was straightened

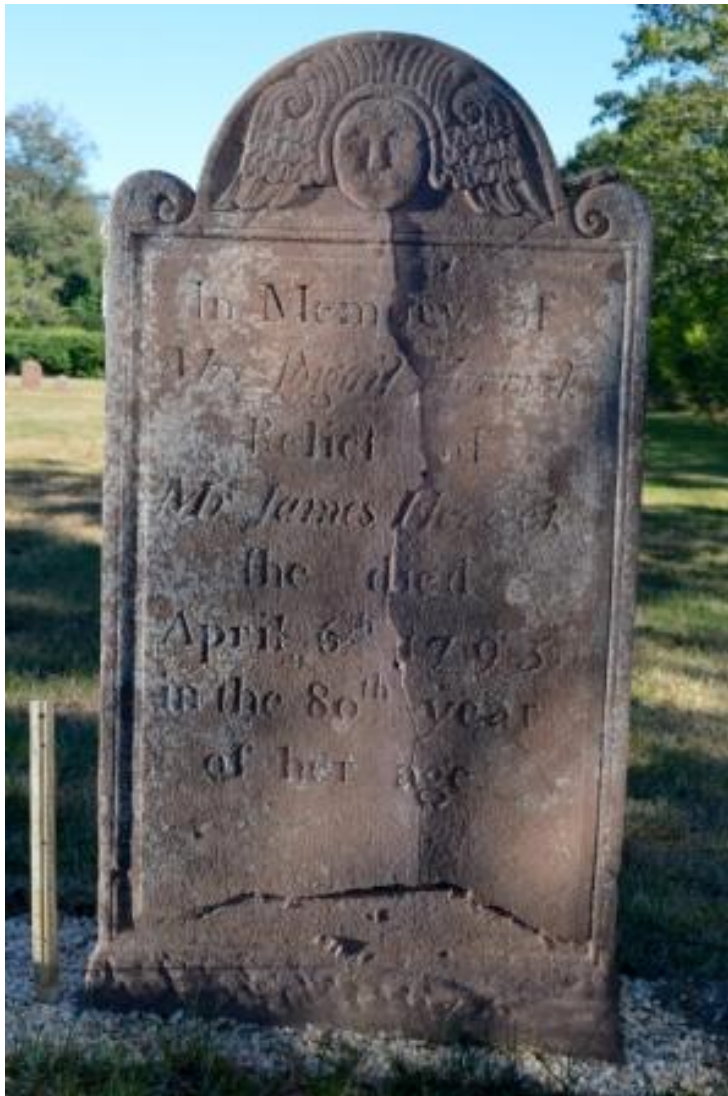
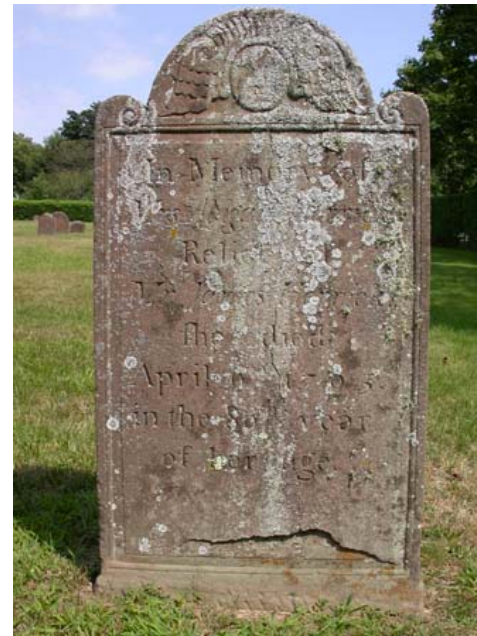
#708 - MRS. ABIGALE HERRICK D. 1795

10/4/2014: HEADSTONE SEPARATING; LIQUID GROUT INJECTED INTO FRONT OF THE HEADSTONE. JOEL SNODGRASS, ZACK STUDENROTH, CHRIS ROBINSON AND DENNIS DELANEY PRESENT.

Condition in
2006
U of Penna

9/24/2015: HEADSTONE & FOOTSTONE STRAIGHTENED.

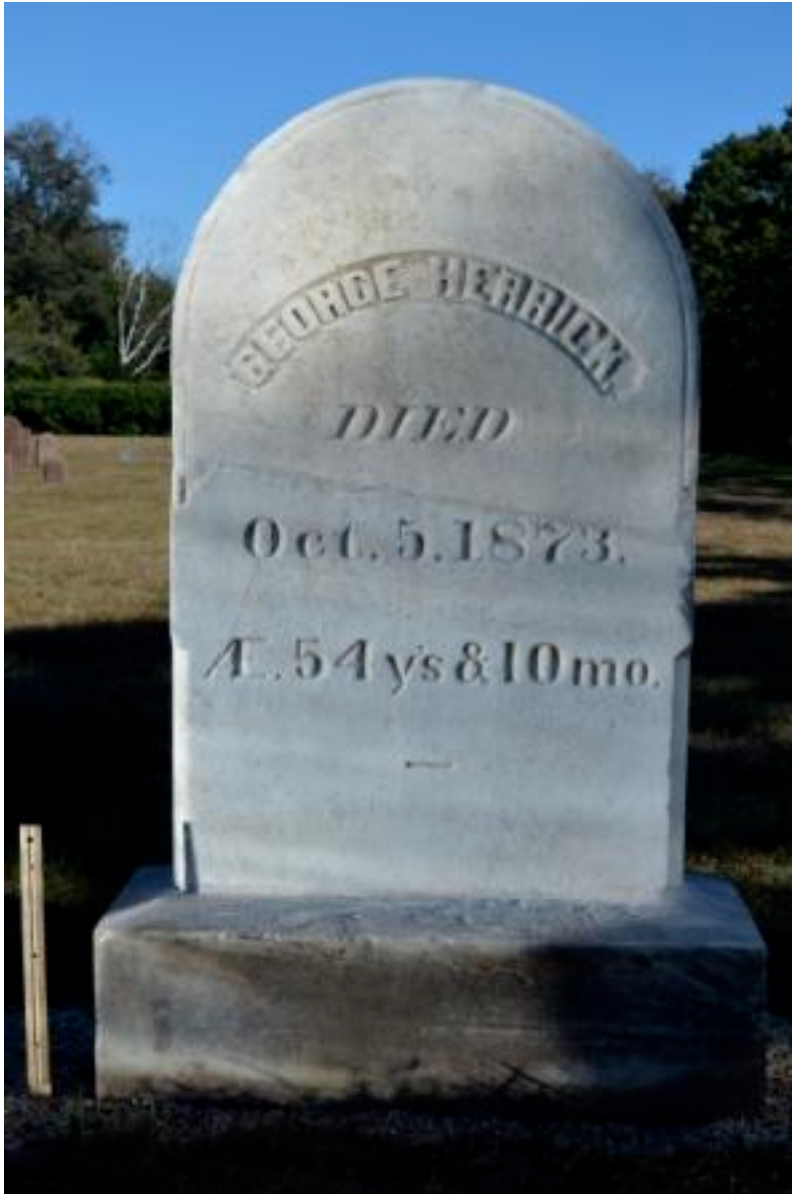
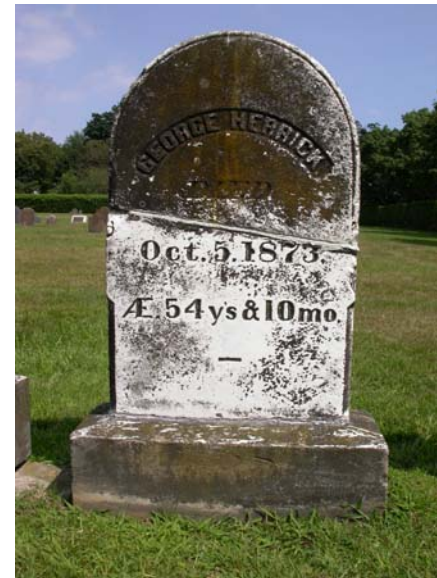
#713 GEORGE HERRICK D. 1873

9/26/2015: HEADSTONE BROKEN AT MID SECTION; EPOXY REPAIR AND RESET INTO PEDESTAL.

Condition
in 2006
U of Penna

9/25/2015: CONCRETE CUT FROM AROUND THE PEDESTAL

9/27/2015: DECORATIVE MORTAR ADDED TO BREAK LINES.

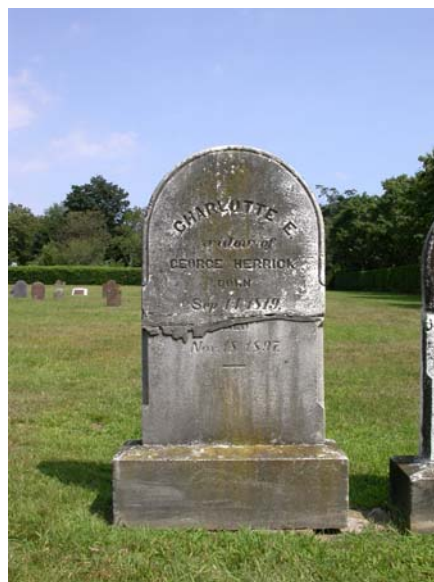
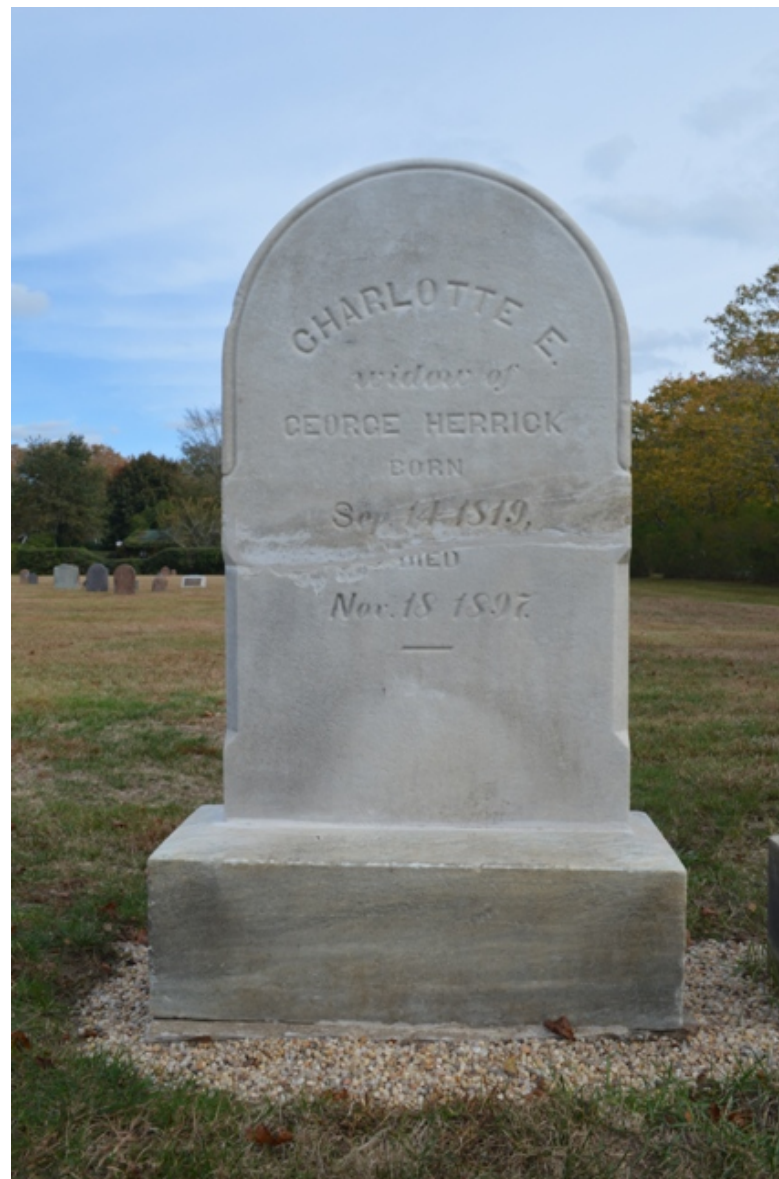
#714 CHARLOTTE HERRICK D. 1897

Condition in
2006
U of Penna

9/25/2015: EPOXY REPAIR OF BOTTOM OF
HEADSTONE PEDESTAL.

9/26/2015: BROKEN MID-SECTION WAS EPOXY
REPAIRED AND RESET TO BOTTOM SECTION.

9/27/2015: DECORATIVE MORTAR ADDED TO
BREAK LINES.

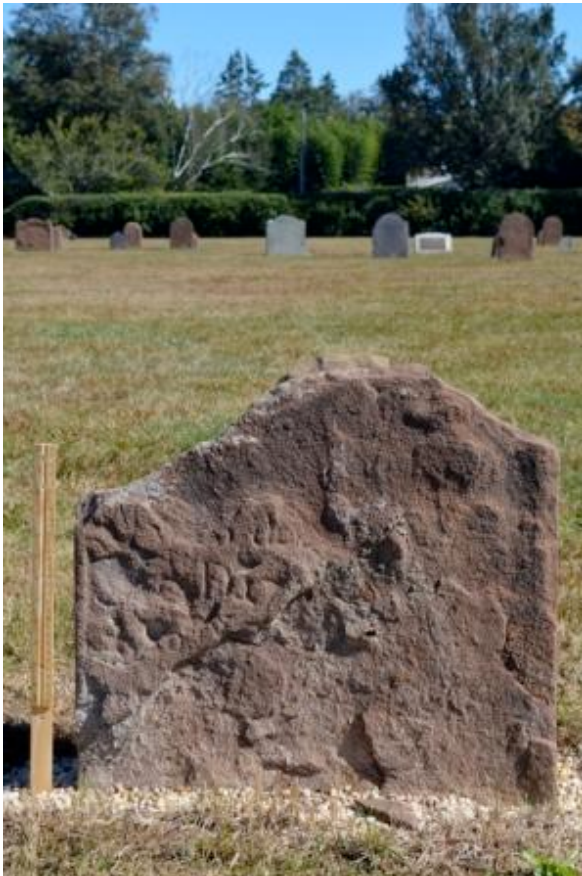
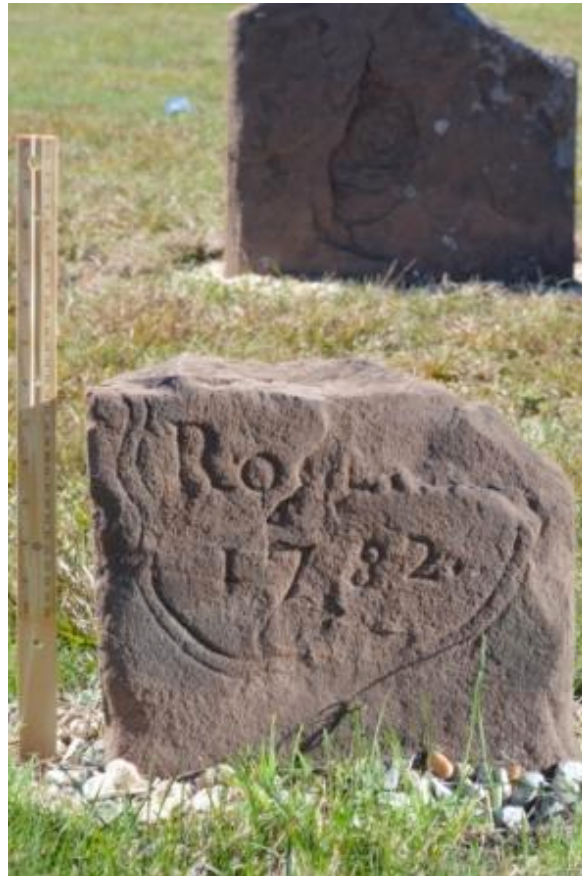
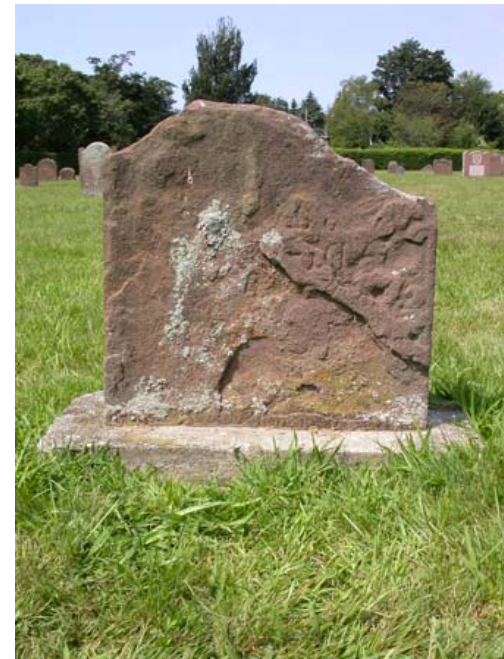
#715 – MRS. ABIGALE ROGERS D. 1782

9/25/2015: CONCRETE REMOVED FROM AROUND THE BOTTOM OF THE HEADSTONE. THE HEADSTONE IS IN BAD CONDITION WITH INSCRIPTION WORN AWAY. MUCH OF IT IS MISSING.

DISCOVERED A LARGE SECTION OF A BROWN STONE UNDERGROUND; IT WAS LATER DETERMINED TO BE FOR THE HEADSTONE OF MR. ROGERS. THE PIECE WAS SET INTO THE EARTH AT THE REAR OF HIS HEADSTONE.

Condition in
2006
U of Penna
